# Asbestos Survey and Paint Sampling Report

Highland Park Avenue Bridge Replacement  
Highland Park Avenue and UPRR Overpass  
Fort Dodge, IA

October 15, 2021

Terracon Project No. 08215031

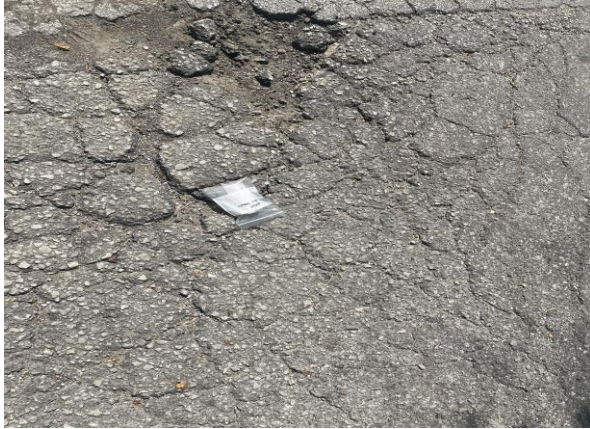
**Eurofins EMLab P&K**3000 Lincoln Drive East, Suite A, Marlton, NJ 08053  
(866) 871-1984 Fax (856) 334-1040 www.emlab.comClient: Terracon Inc. - Des Moines  
C/O: Kemp Johnson, Anita Maher-Lewis  
Re: Highland Park Ave Over UPRR ReplacementDate of Sampling: 09-15-2021  
Date of Receipt: 09-16-2021  
Date of Report: 09-21-2021**ASBESTOS PLM REPORT****Total Samples Submitted:** 6**Total Samples Analyzed:** 6**Total Samples with Layer Asbestos Content > 1%:** 0**Location: Asphalt-01, Asphalt From South Side of Road**

| Sample Layers | Asbestos Content |
|---|---|
| Black Asphalt | ND |

**Photo #1** Sample 1-3 – Non-asbestos containing asphalt.

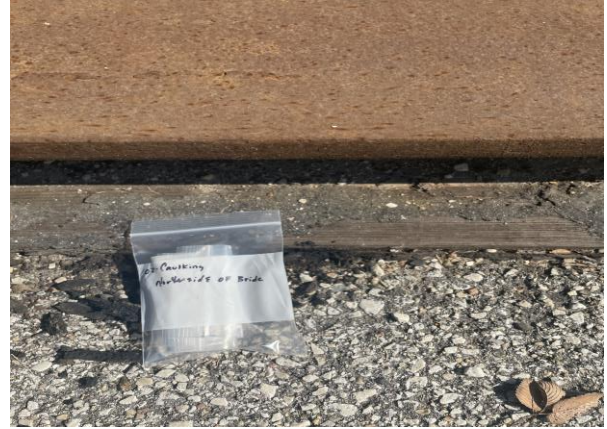
**ASBESTOS PLM REPORT****Location: Caulking-04, North Side Bridge Deck**

| Sample Layers | Asbestos Content |
|---|---|
| Black Caulk | ND |

**Photo #2** Samples 4-6 – Non-asbestos containing caulking
