Design for Repair  
**KARL KING BRIDGE**  
**PIER #4 - NORTH COLUMN**  
On Iowa #7. May, 1979  
**WEBSTER COUNTY**  
IOWA DEPARTMENT OF TRANSPORTATION-HIGHWAY DIVISION  
Design Sheet No. 1 Of 1 File No. 26214 Design No. 679

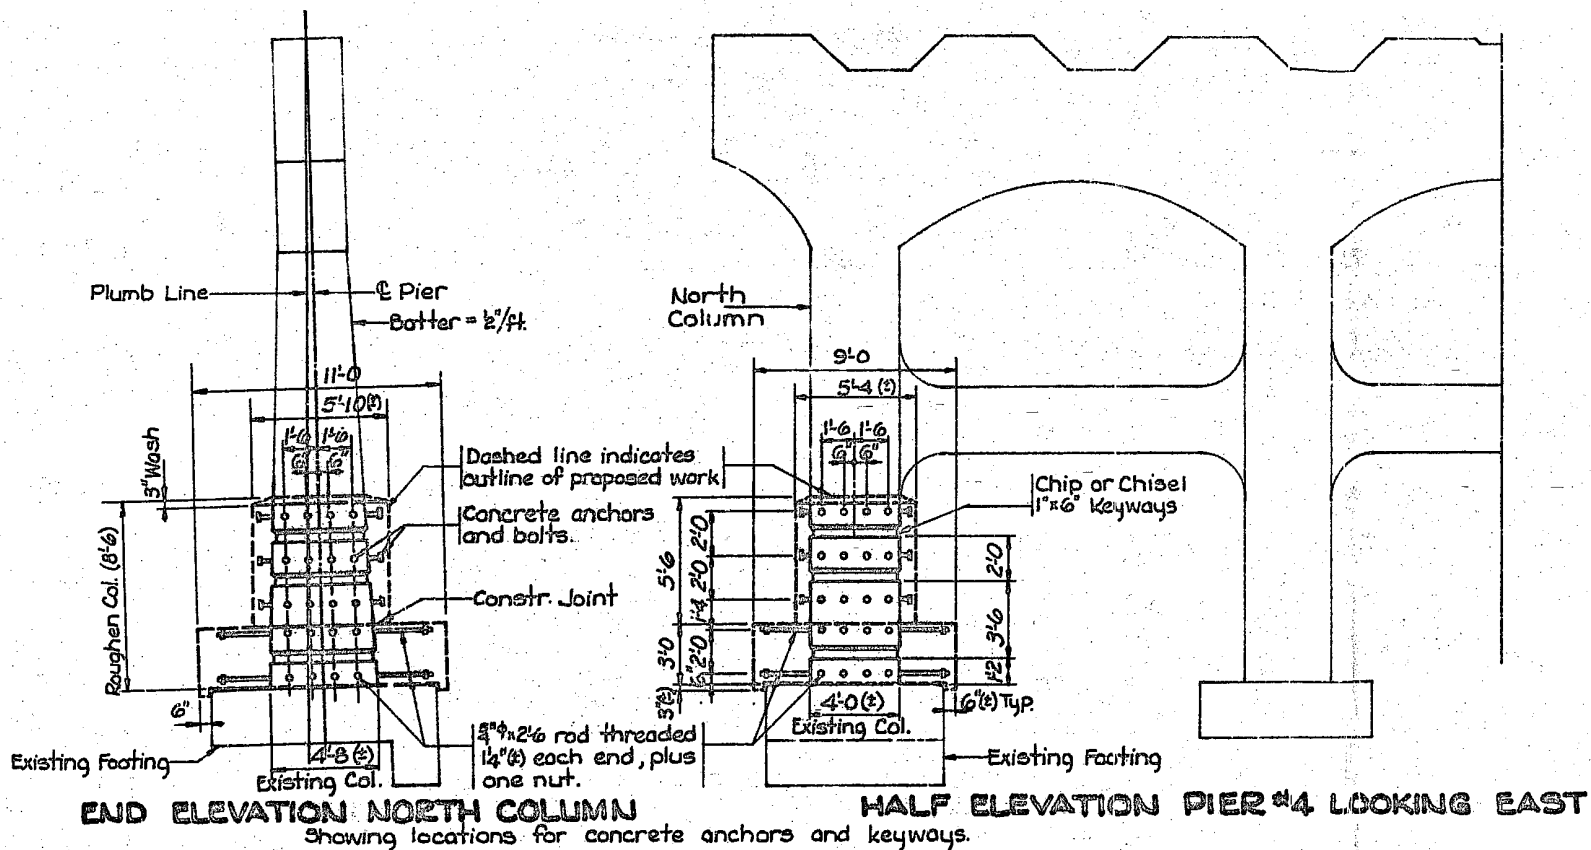
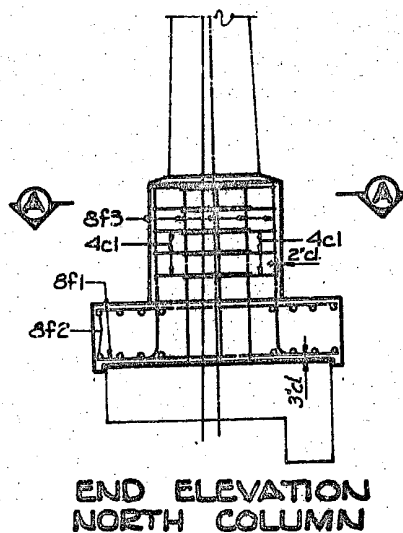
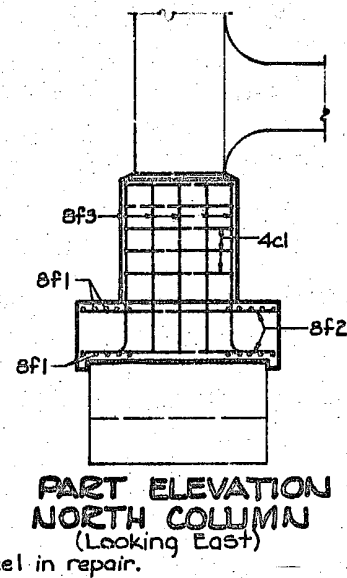
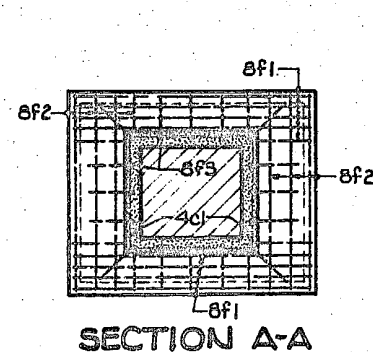
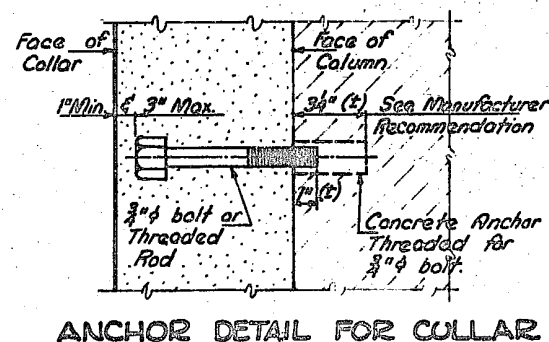
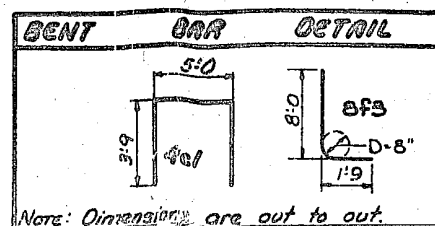
**NOTES:**  
The footing supporting the north column of the most westerly two-story frame-type pier is severely cracked. The purpose of this repair is to prevent a sudden failure of this pier should additional settlement occur.  
The repair consists of adding a reinforced concrete cap on top of the damaged footing and a reinforced concrete collar around the lower portion of the column. The concrete anchor bolts, the keyways cut into the column and the roughening of the column are to insure the structural integrity of this repair. Roughening of column should be accomplished using a chipping tool or other suitable means. The top of the existing footing should be thoroughly cleaned prior to placing concrete but it need not be saturated with water. It is intended that the collar concrete bond to the column so the Standard Spec. 2403.15 will apply for that.  
The concrete anchors shall be one of those brands approved by Materials I. M. 453.09, such as: Hilli, Rawl or Star.

**MATERIAL LIST:**  
48 - 3/4" x 0-7 bolts.  
32 - 3/4" x 2-6 threaded rod with nut.  
80 - 3/4" concrete anchors.
